# Apartment Glulam Dry-rot Damage Inspection

Report completed by: INTERNATIONAL BUILDING INVESTMENT  
On site Representative: David Gill  
Date: 3-2-10

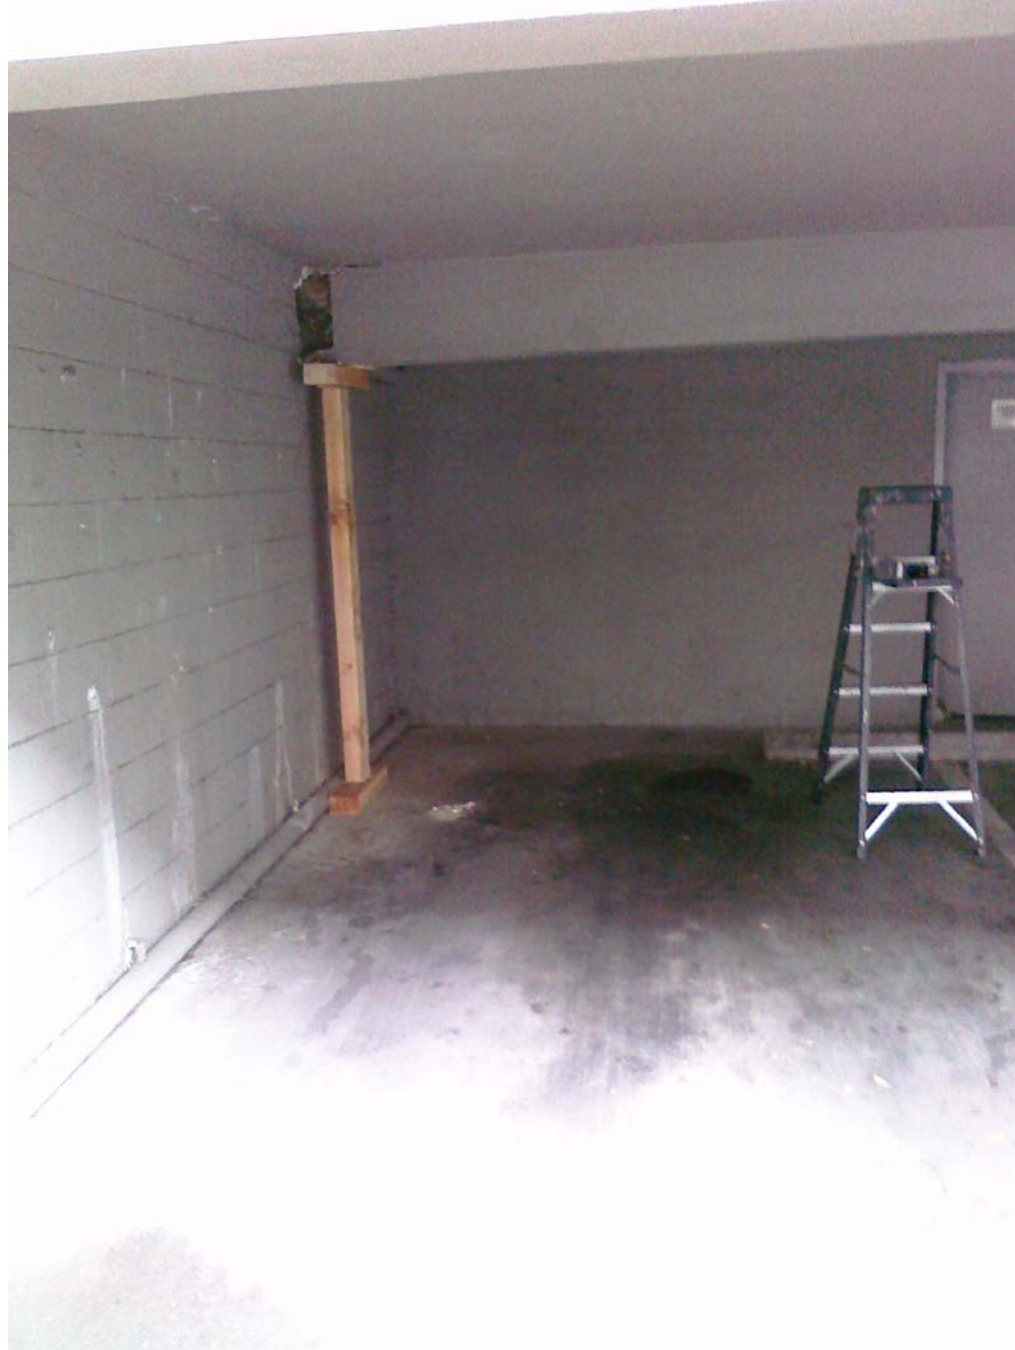
Glulam shows sign of dry-rot. Water appears to have come from other side hole in block wall for plastic electrical chase.

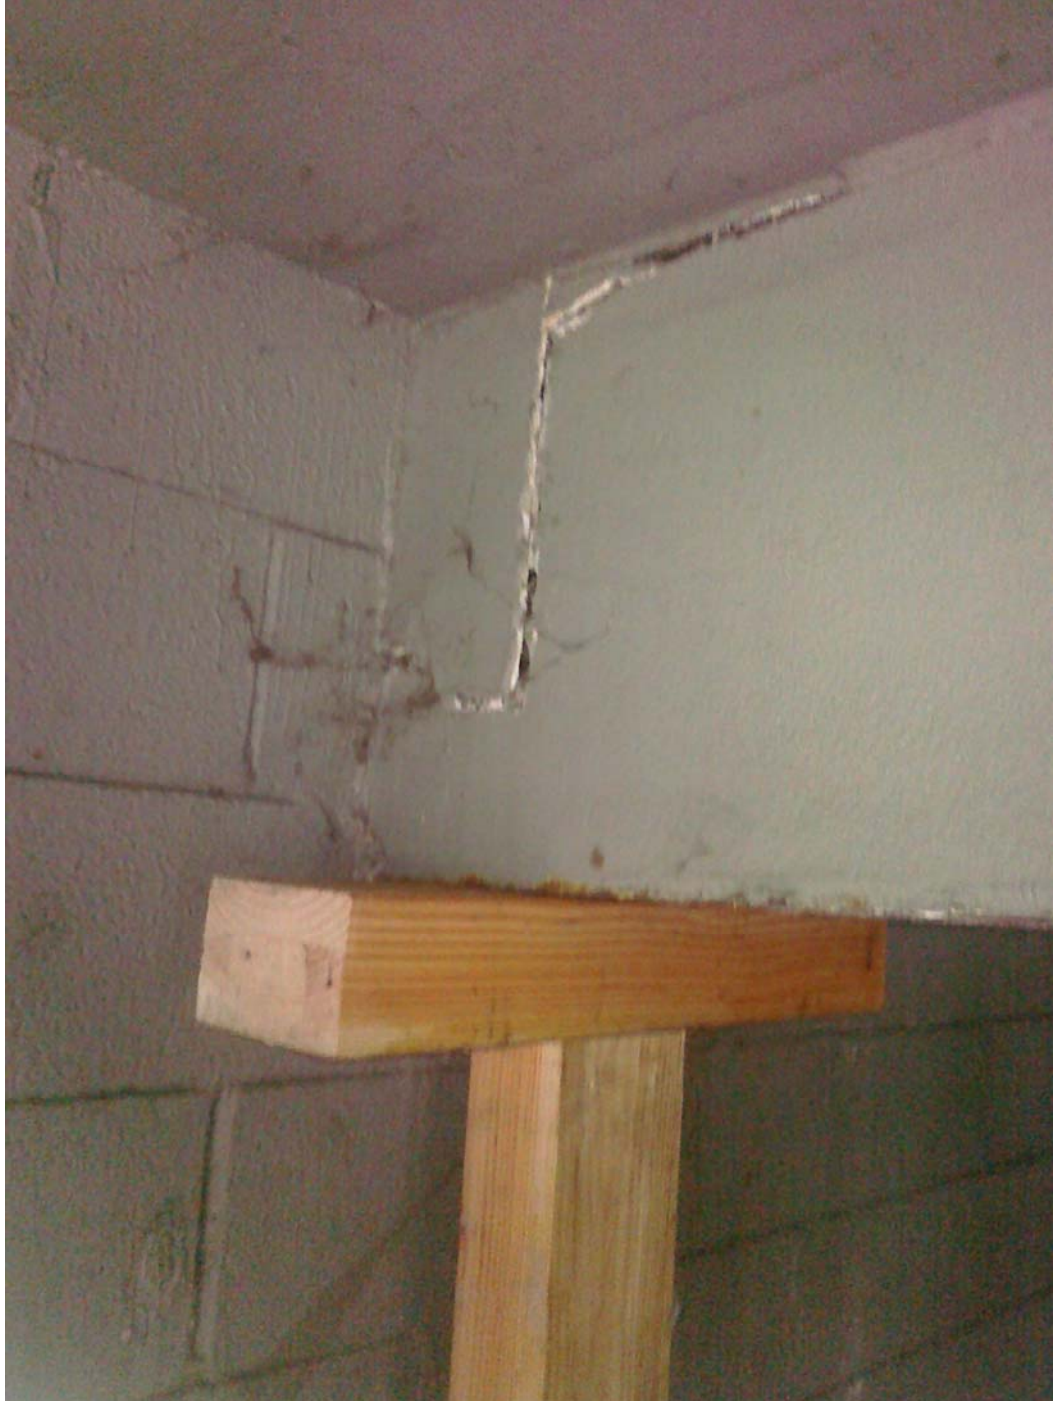
Initial view of glulam after temporary shoring for safety prior to removal of stucco to assess damage.

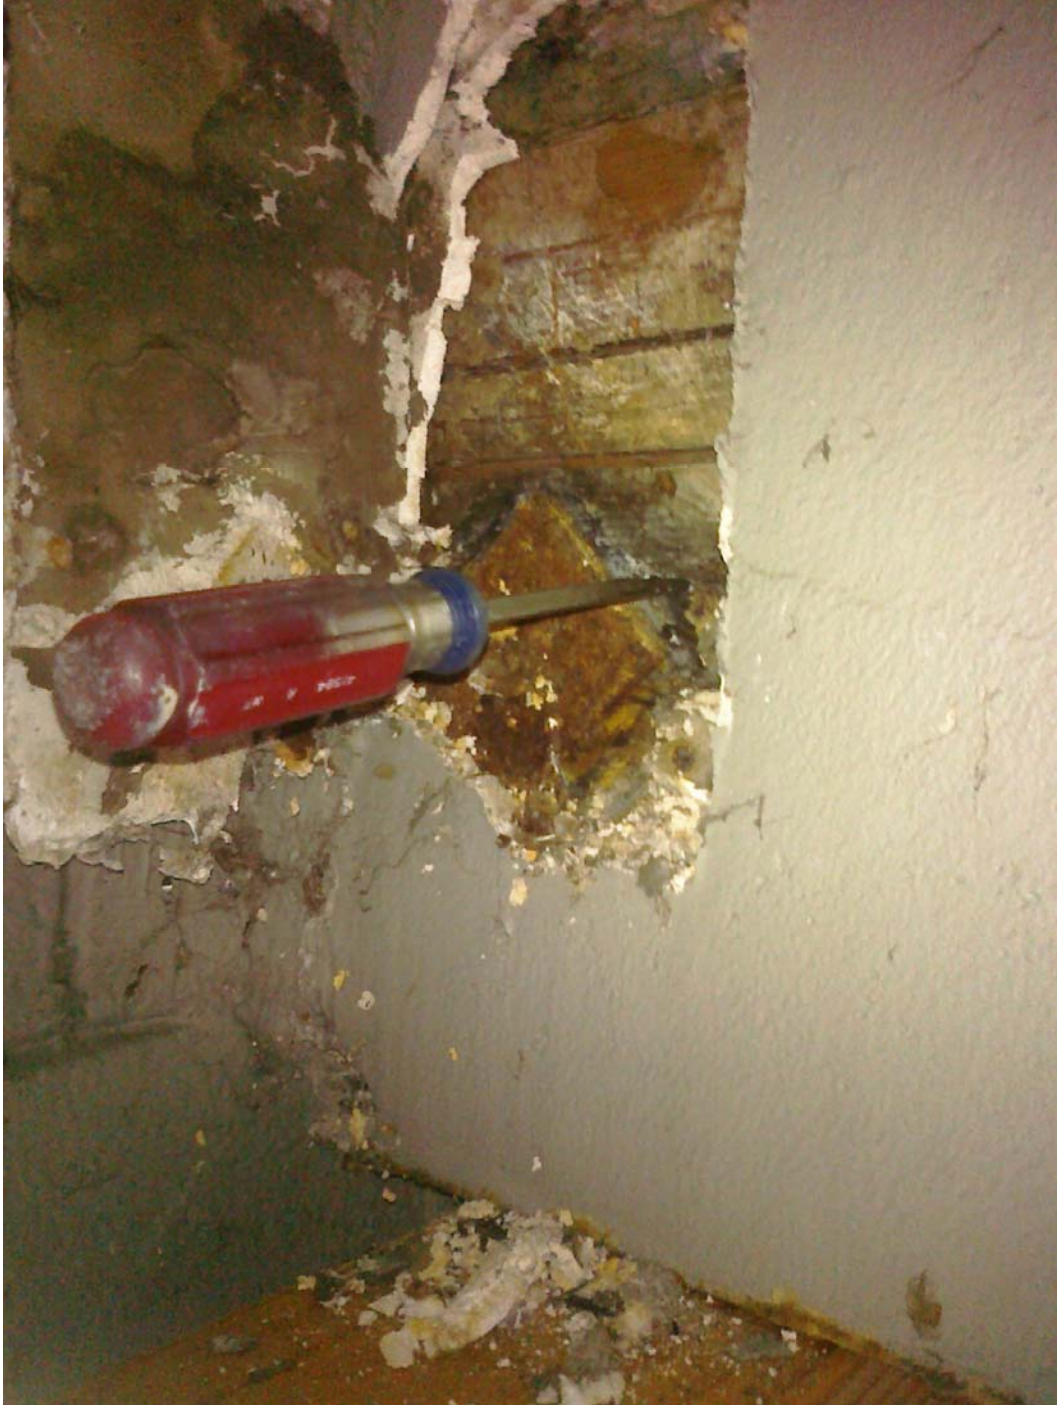
Close up of initial Dry-rot on Glulam. Do to potential safety risk immediately purchased additional post and shored up glulam 6' back before opening up additional stucco to assess full damage of dry-rot.

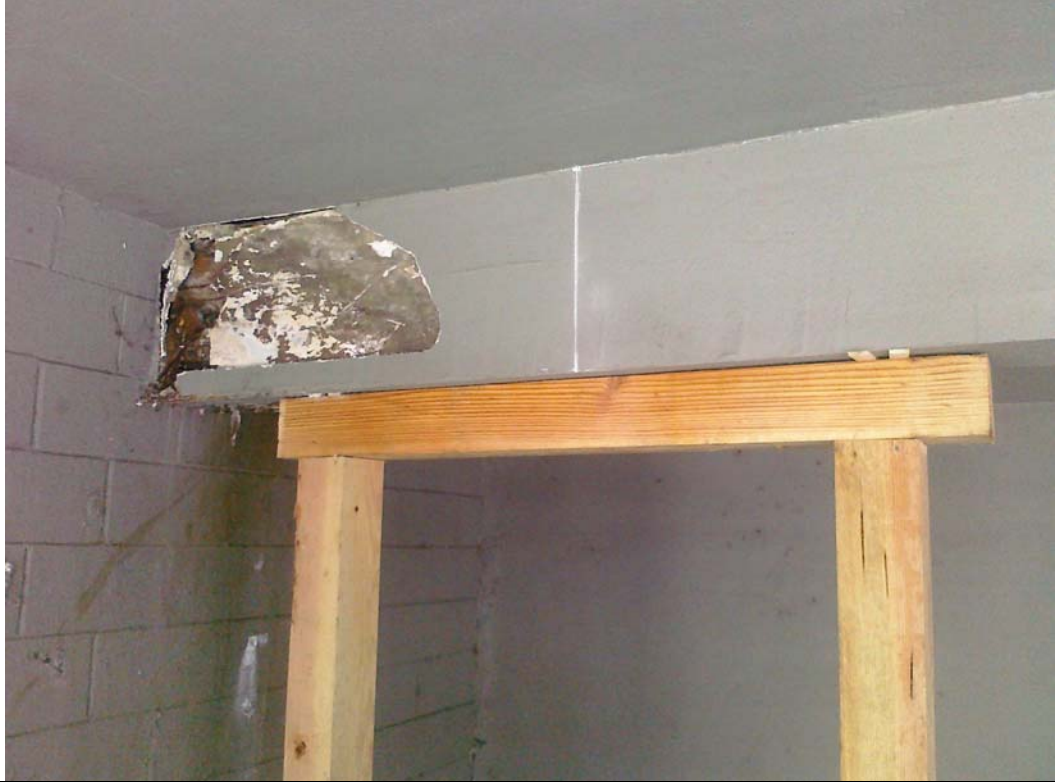
Additional post shored up for safety

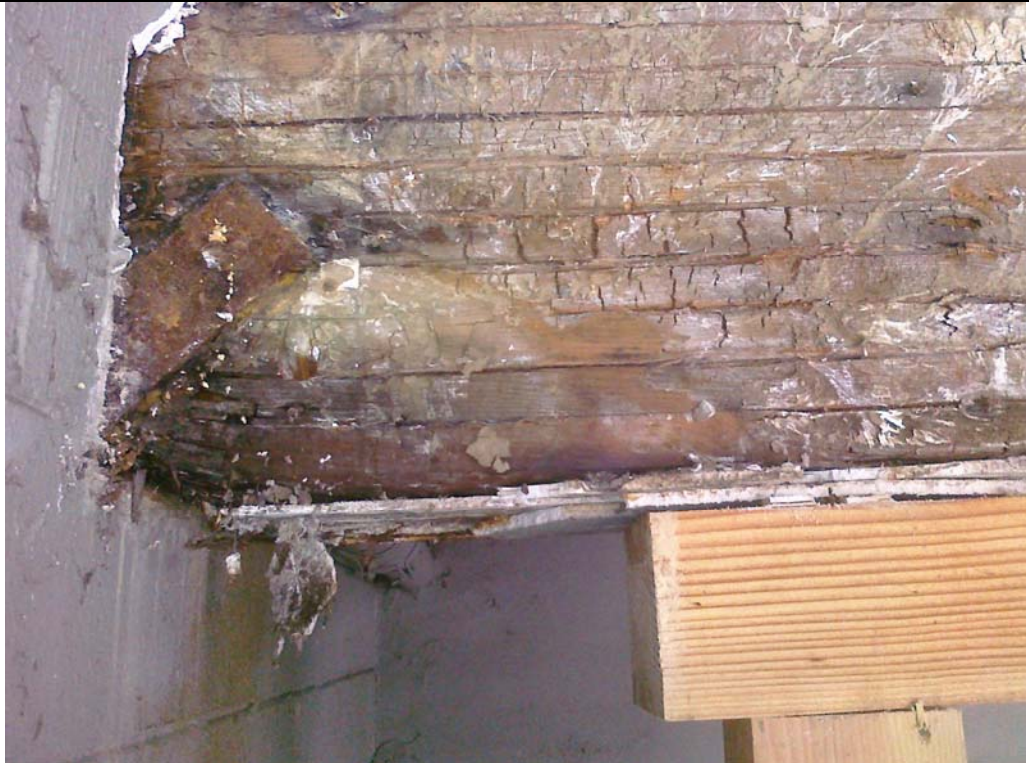
View of dry-rot damage not including the glulam part on the block wall its self.

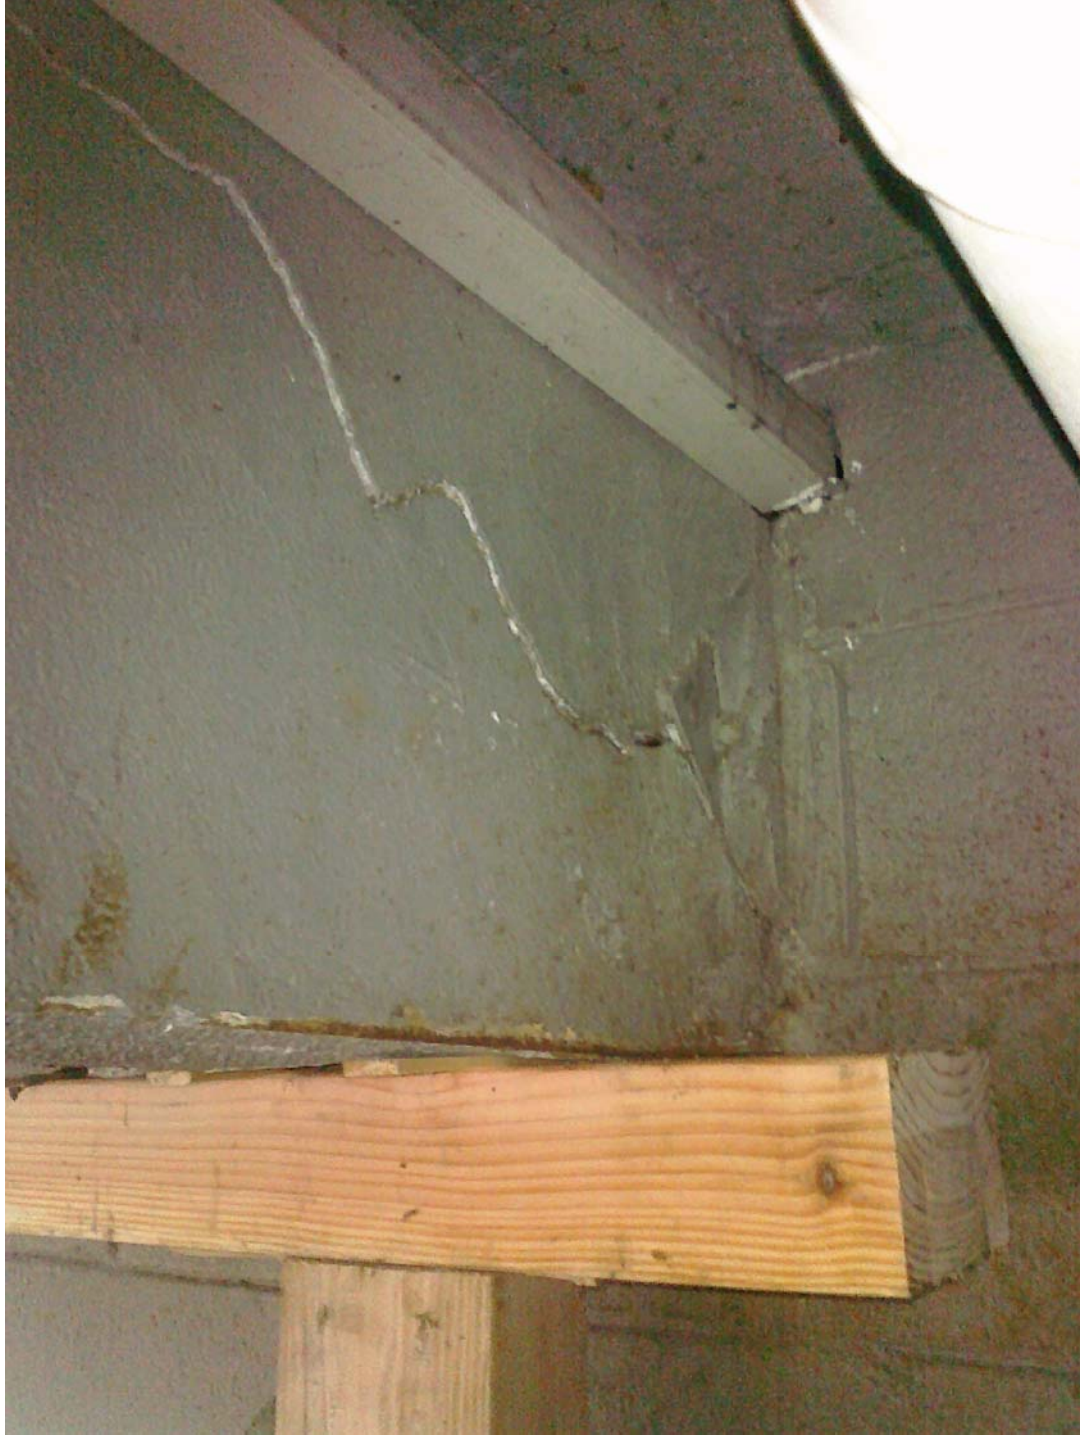
Other side  
of Glulam  
showing the  
source of  
water

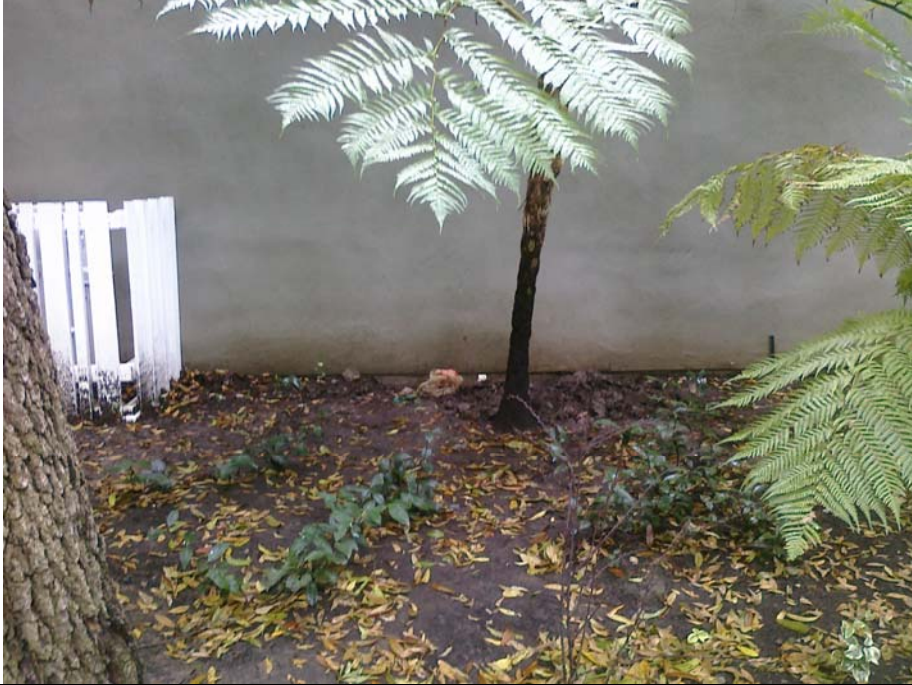
Outside wall causing the water to get inside

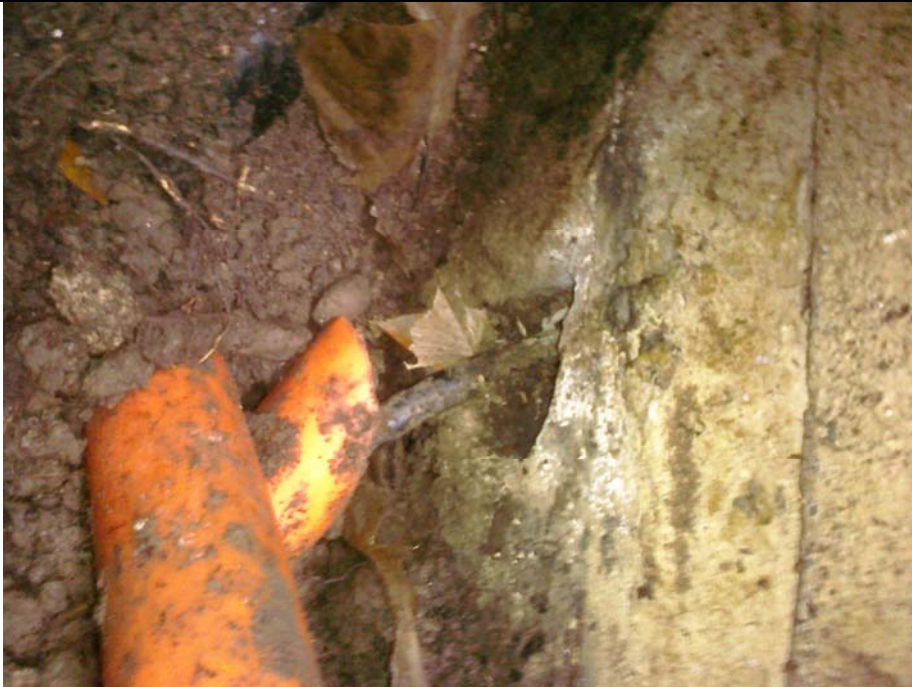
Close up of ground/ electrical penetration into block wall.
